**CRYOGENIC FLUID
MANAGEMENT EXPERIMENT
TRUNNION VERIFICATION TESTING**

by W.J. Bailey, and D.A. Fester

MARTIN MARIETTA DENVER AEROSPACE

1. Report No. NASA CR-168310		2. Government Accession No.		3. Recipient's Catalog No.	
4. Title and Subtitle Cryogenic Fluid Management Experiment (CFME) Trunnion Verification Testing				5. Report Date December 1983

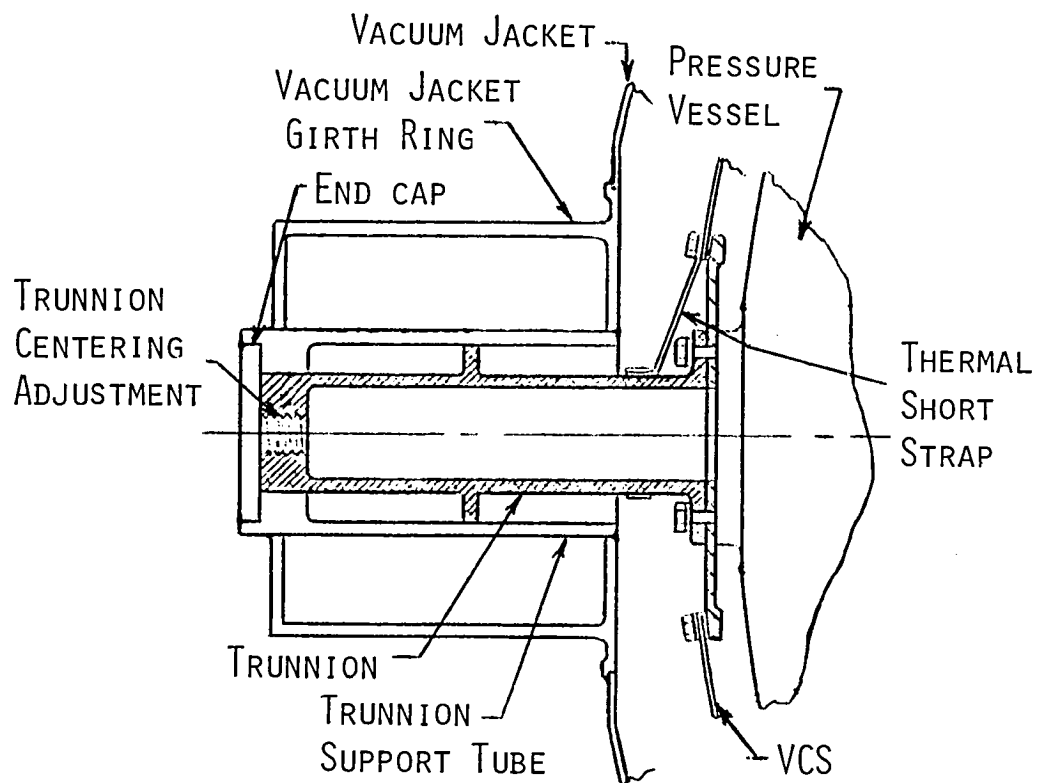
Figure I-3 Trunnion Mounting Configuration

The CFME composite support trunnion was analyzed and designed in detail under contract NAS3-21591 (Ref 1). The vacuum jacket girth ring interfaces with the liquid hydrogen storage vessel through two support trunnions. The trunnion mount configuration is shown in Figure I-3. This design resulted from an assessment which considered both the thermal requirements and the structural design as driven by fatigue for seven-mission life. One trunnion is adjusted to the proper position prior to final closeout welding of the support tube assembly by a threaded and vented fitting. It is called the

fixed trunnion. The other trunnion allows for contraction and expansion of the pressure vessel and is termed the floating trunnion. The pressure vessel is therefore slightly offset (unsymmetrical support) in the unloaded condition, but becomes symmetrical in the loaded (cold and contracted) condition.

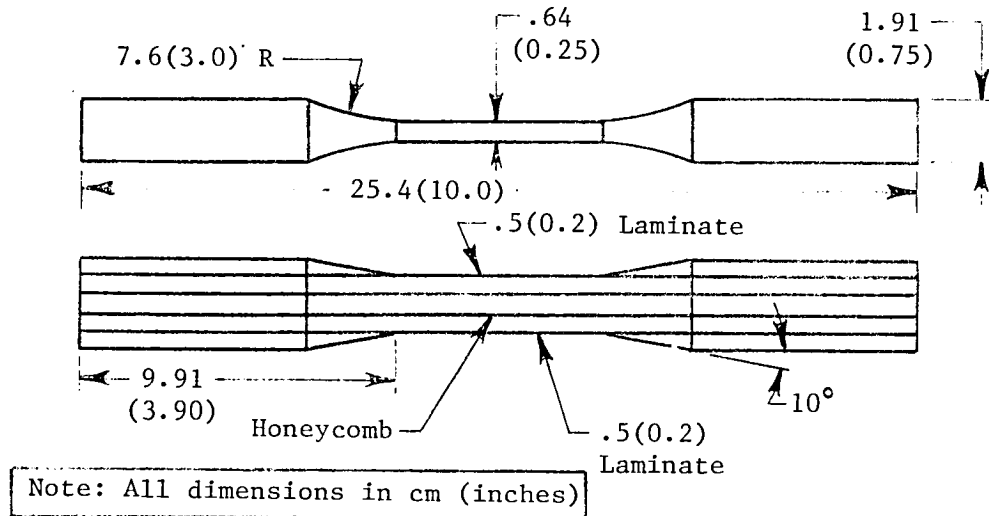
Figure II-1 Original Test Specimen Configuration

An evaluation of the proposed test specimen configuration was conducted after it was determined that both the specimen gage section and the test fixture clamping jaws were inadequate for tension-compression fatigue loading. The original design (taken from Ref. 3), shown in Figure II-1, had an insufficient cross-sectional area in the gage section. In addition, it was felt that the difference in thermal contractions of the composite and the stainless steel clamping jaws would not provide an adequate grip for a long-term cyclic fatigue test at LH₂ temperatures.

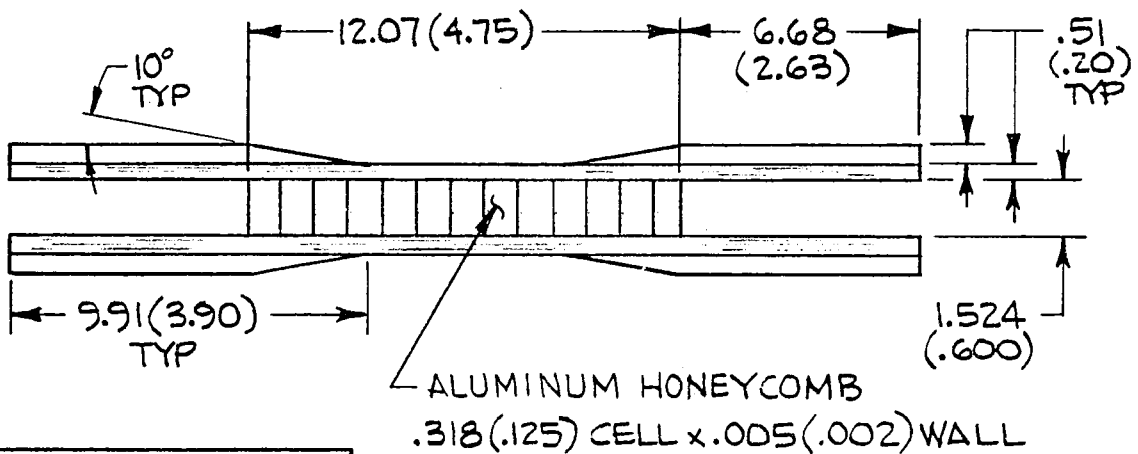
Figure II-2 Interim Test Specimen Configuration

A new specimen configuration was proposed (Figure II-2), which had an increased width in the gage section and a clevis arrangement at each end for interface with the tongues of the testing machine (Figure II-3). Specimen securing was provided by a four bolt attachment at each end. This configuration was assessed from the stand point of complexity of manufacture and chance for success in obtaining the required information from the test series. Objections to this design were:

SPECIMEN LAYUP												
0°	45°	0 ₂ °	45°	0 ₂ °	45°	0 ₂ °	45°	0 ₂ °	45°	0 ₂ °	45°	0°
.03	.023	.061	.023	.061	.023	.061	.023	.061	.023	.061	.023	.03
(.012)	(.009)	(.024)	(.009)	(.024)	(.009)	(.024)	(.009)	(.024)	(.009)	(.024)	(.009)	(.012)

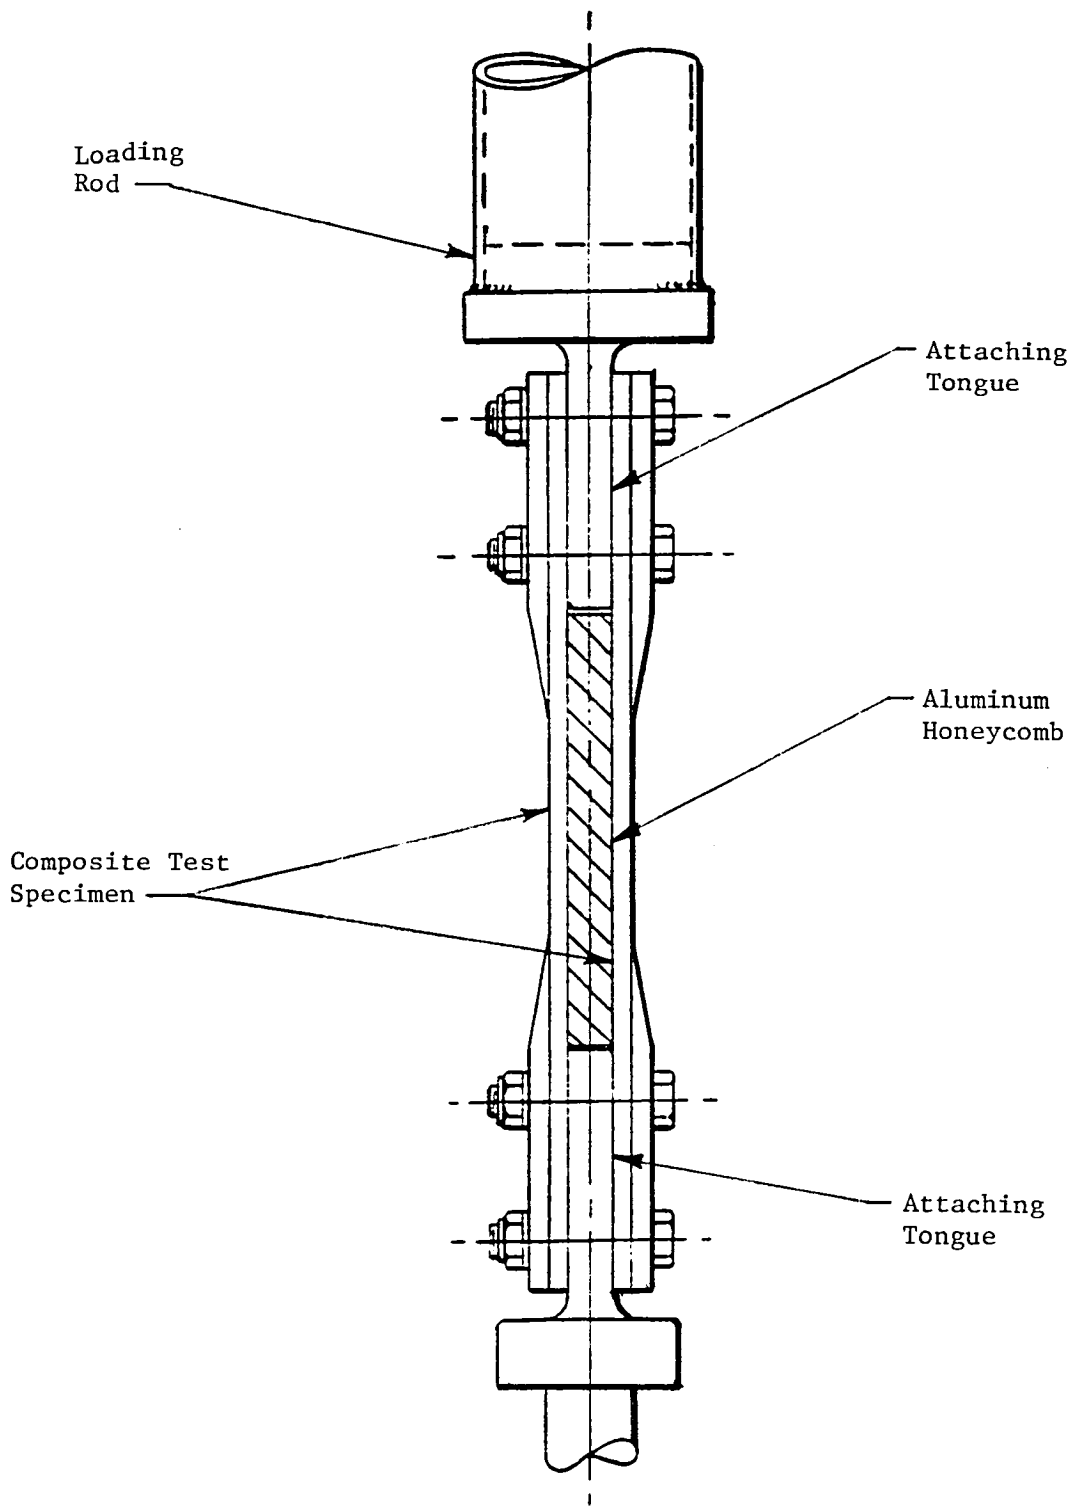
Figure II-3 Interim Test Specimen/Test Machine Interface

- 3) Trapped air within the honeycomb would be unacceptable during LH_2 testing resulting in the need for using a perforated honeycomb or having to punch holes through all of the honeycomb cells;
- 4) Having a double coupon, doubled the size of the load applied by the testing machine and increased the size of the supporting structure of the cryostat, resulting in a higher heat leak;
- 5) The width of the coupon, 3.56 cm (1.4 in.), and the fact that the specimens were off the centerline of the loading would create the potential for the stress in each side to be unequal, which was unacceptable.

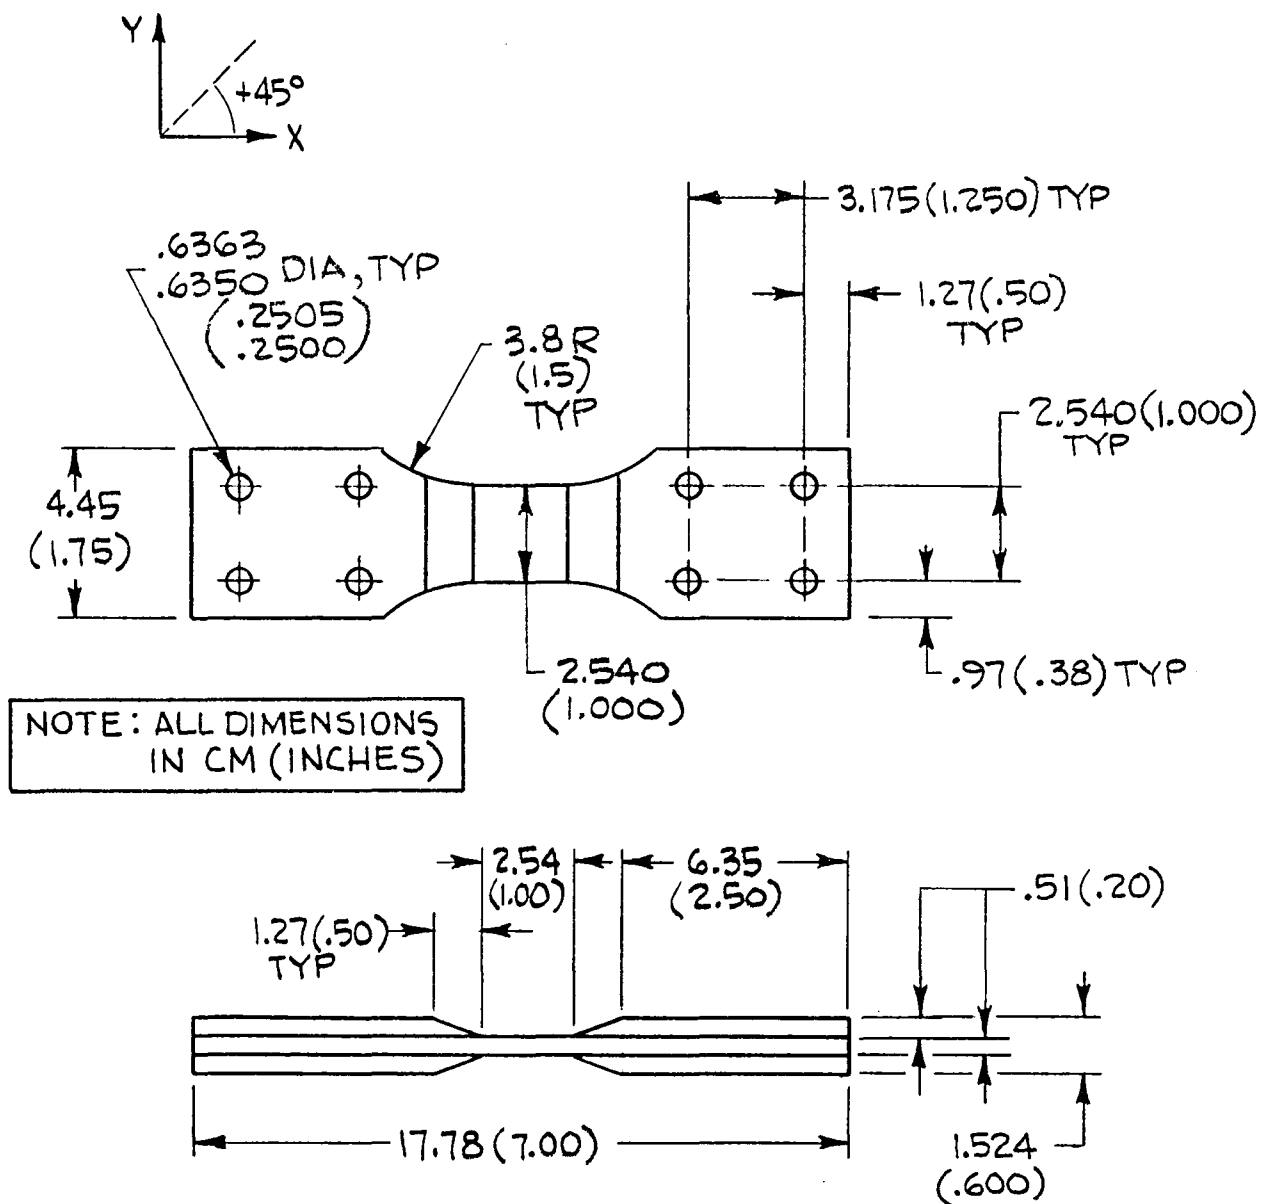
Figure II-4 Selected Laminate Test Specimen Configuration

- 1) E-glass cloth on the outside avoided the possibility of 0° unidirectional ply peeling of the S-glass roving. This consideration was the driving factor to change the lay-up configuration;

SPECIMEN LAYUP									
-45	0°	+45°	0°	+45°	-45°	0°	+45°	0°	-45°
.023	.091	.023	.091	.023	.023	.091	.023	.091	.023
(.009)	(.036)	(.009)	(.036)	(.009)	(.009)	(.036)	(.009)	(.036)	(.009)

- 2) Extension-shear coupling and bending-twisting coupling was reduced by using orientations of -45° and $+45^{\circ}$ fabric plies (E-glass cloth) when compared to that offered by the original lay-up which used only $+45^{\circ}$ orientations.

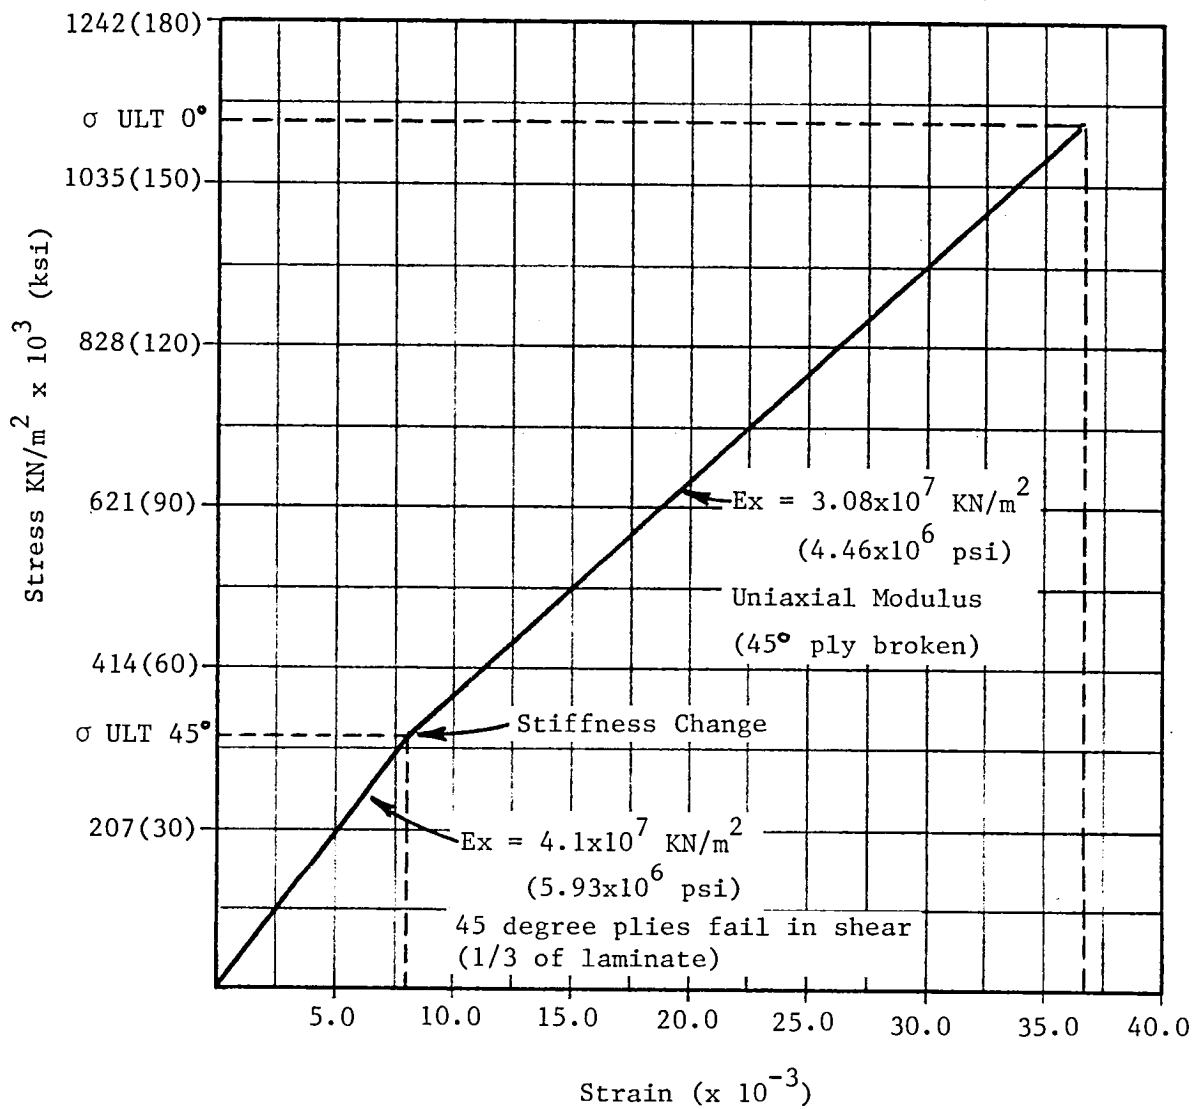
Figure II-6 X-Direction Stress/Strain Diagram for CFME Laminate

The inherent fact that the laminate was composed of two materials (S-glass roving in the 0° plies, and E-glass cloth in the 45° plies) with greatly varying stiffnesses posed the problem of how a failure of the laminate could be detected. A review of the trunnion stress analysis (Ref 5) showed that the calculations were all based on an assumed laminate ultimate strength of 334,650 kN/m² (48,500 psi) when in fact this number more closely represented the ultimate strength of just the 45° E-glass cloth (as shown by

the knee in the curve in Figure II-6). The ultimate strength of the overall laminate was analytically determined by the SQ5 program to be on the order of $1,104,000 \text{ kN/m}^2$ (160,000 psi) after failure of all 45° plies (1/3 of the laminate), as shown in Figure II-6. The object of the testing therefore was to determine, if possible, the loading and cycling values which would indicate a failure of the 45° E-glass cloth. This failure, however, was not visually observable and could only be obtained through proper test instrumentation (strain gage and deflection readings). The effect of this failure mode on the overall laminate stiffness was also required for material property evaluation.

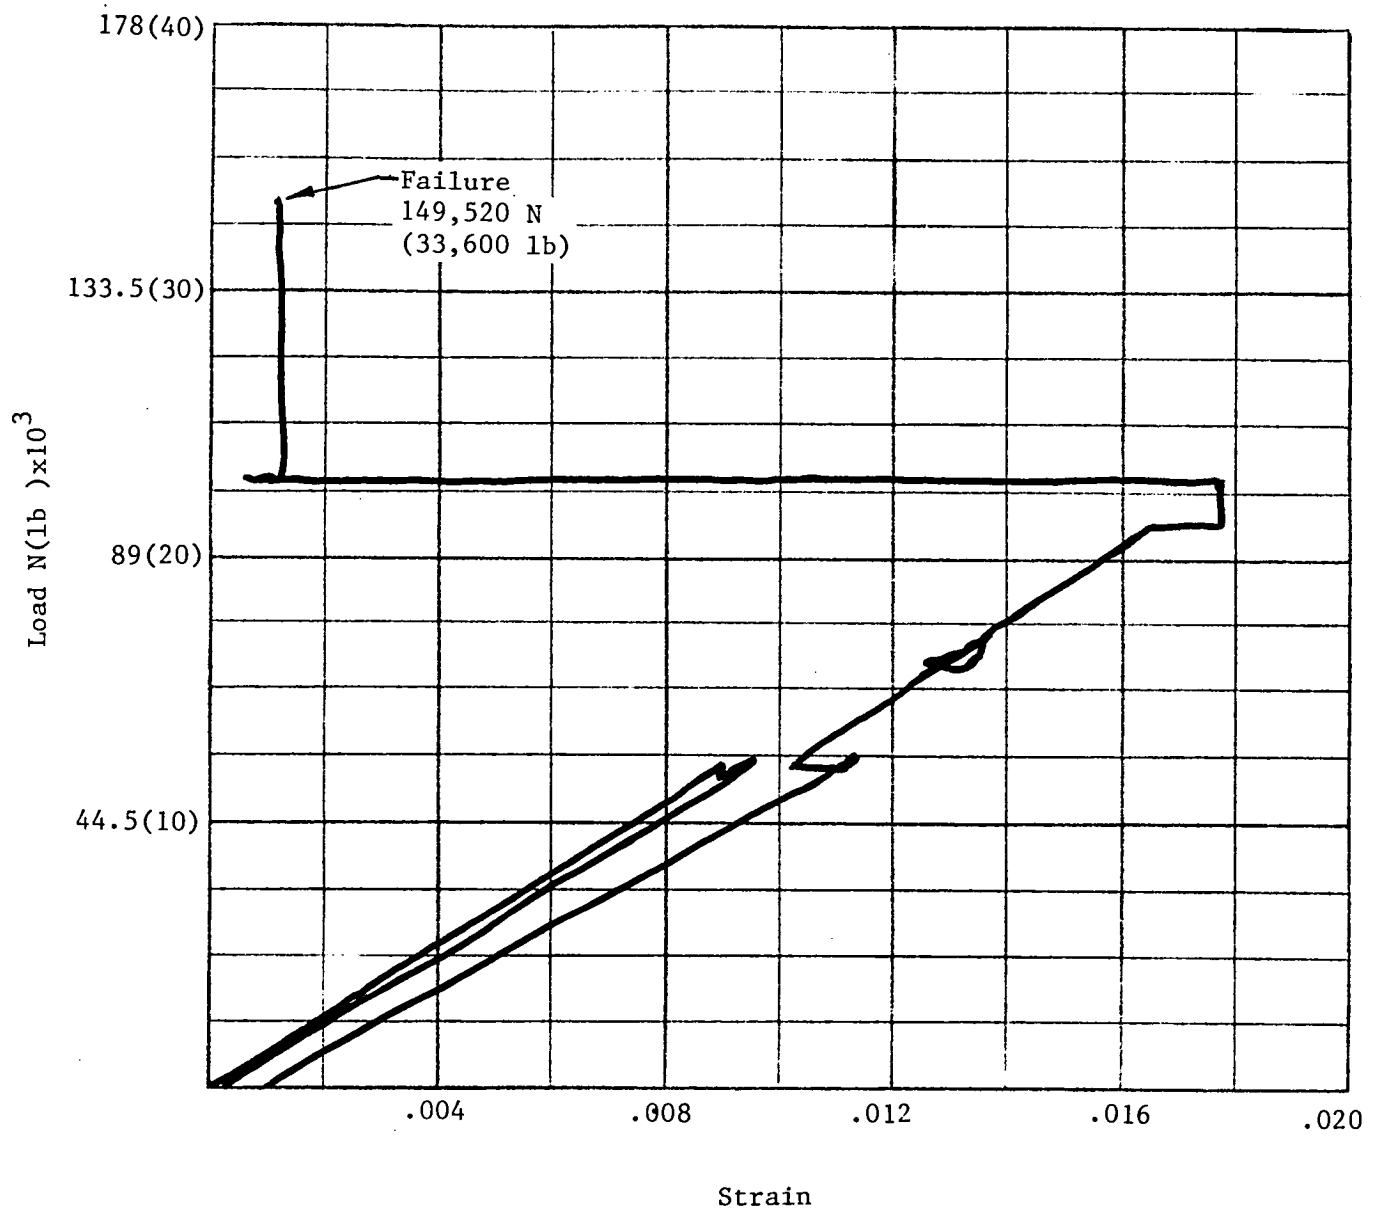
Figure II-7 Laminate Load/Strain Curve

The specimens had strain gages installed for specimen alignment and data collection. Figure II-7 shows the load/strain curve for specimen number 4. This test consisted of two specimen loadings; the first loading resulted in a discontinuity at 53,400 N (12,000 lb) after which the load was decreased to zero; the second loading also resulted in a discontinuity between 53,400 N (12,000 lb) and 55,625 N (12,500 lb), another at 73,425 N (16,500 lb) and specimen failure at 149,520 N (33,600 lb). The strain gage failed at 93,450 N (21,000 lb).

The expected change in slope of the stress/strain curve due to the decreasing longitudinal elastic modulus of the specimen did not occur. The lowest of the three loads, 53,400 N (12,000 lb), where discontinuity of the stress/strain curve appeared, was selected as an arbitrary "failure" point. This point became the base line for the 100%, 80%, 60% and 40% loading conditions for the ambient temperature fatigue tests. This compares to the 40,940 N (9,200 lb) used in the original CFME trunnion analysis and is 30% greater. The actual tested stress value at this so-called "failure" point was $483,000 \text{ kN/m}^2$ (70,000 psi) compared to the $317,400 \text{ kN/m}^2$ (46,000 psi) used in the analysis. These preliminary results indicated a much stronger laminate than originally predicted.

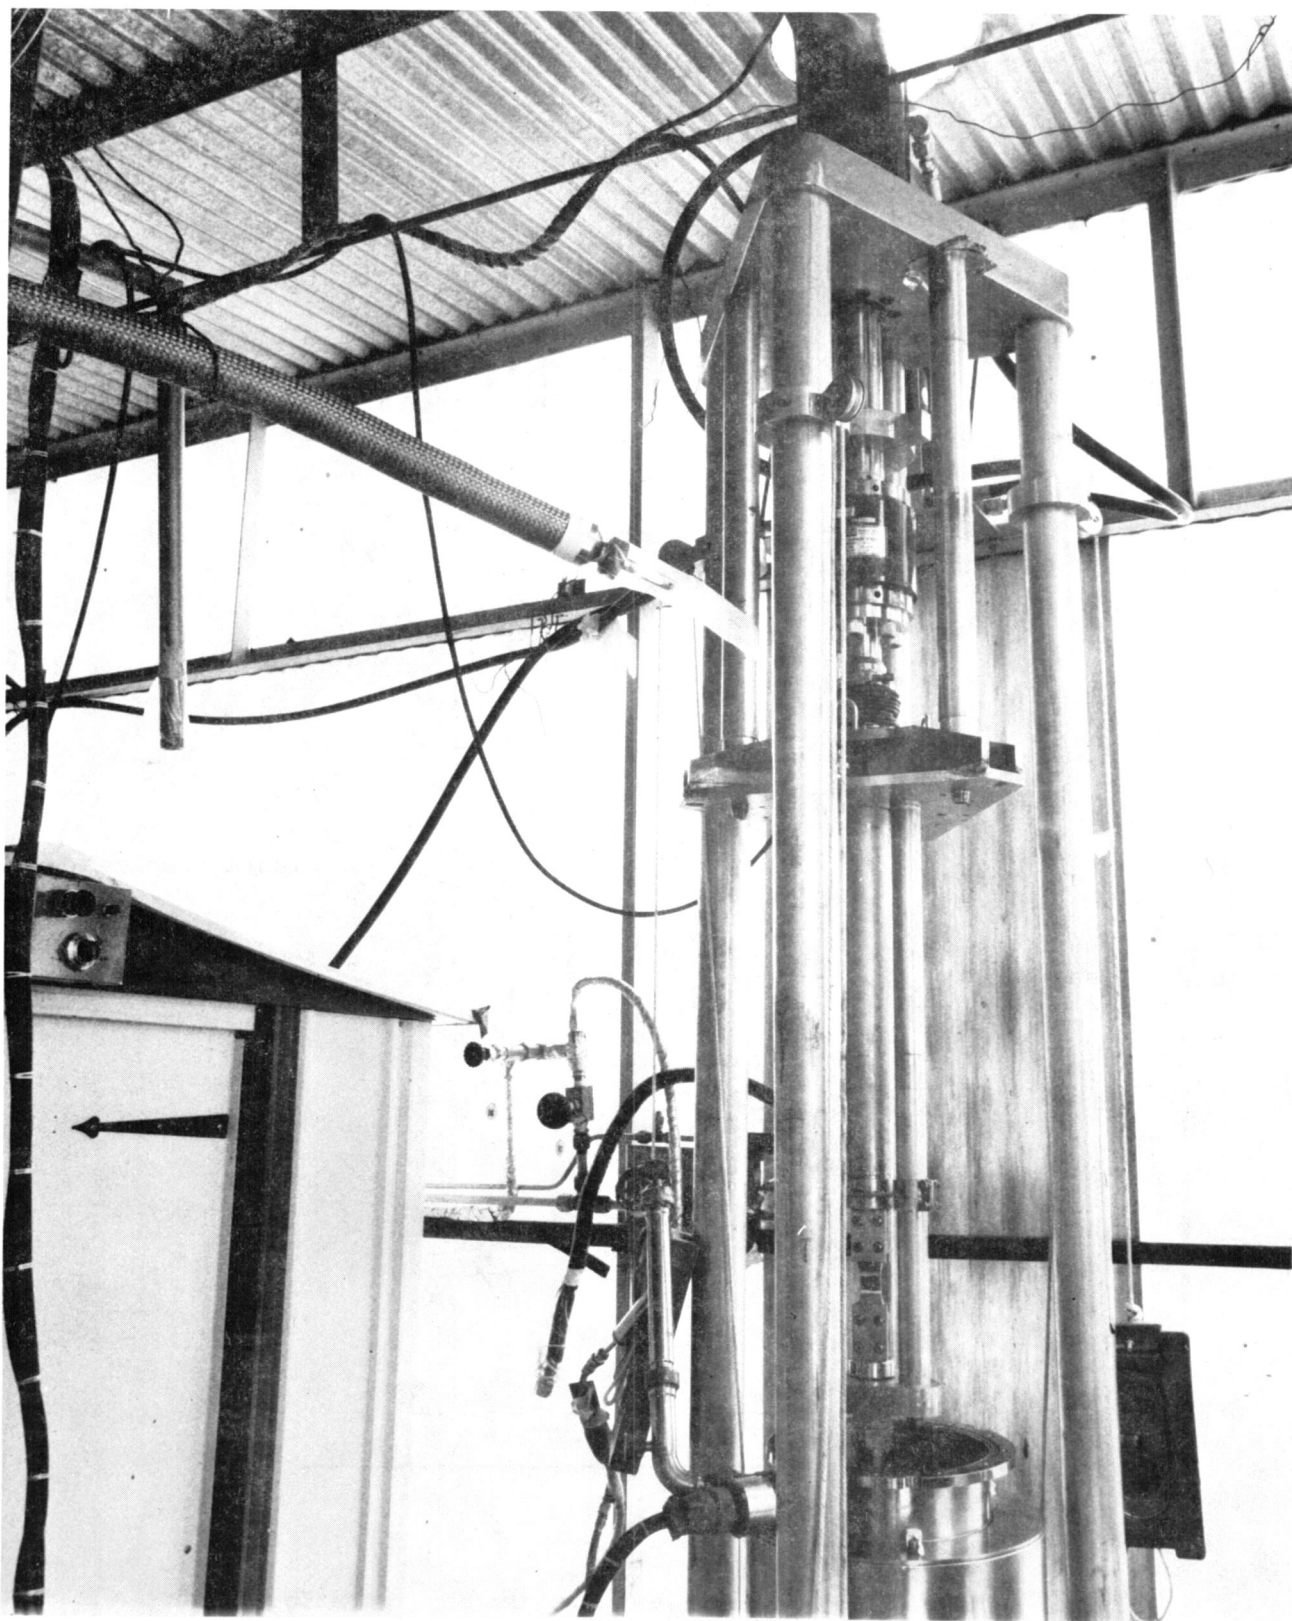
Figure II-9 Specimen Fatigue Test System

The first test series was conducted in air at ambient temperature using the cryostat fixture without the cryogenic reservoir. Figure II-9 shows the test setup configured for these tests. The second test series was conducted with the specimen immersed in LH_2 . Figures II-10 and II-11 show the assembled test fixture with the cryostat reservoir installed.

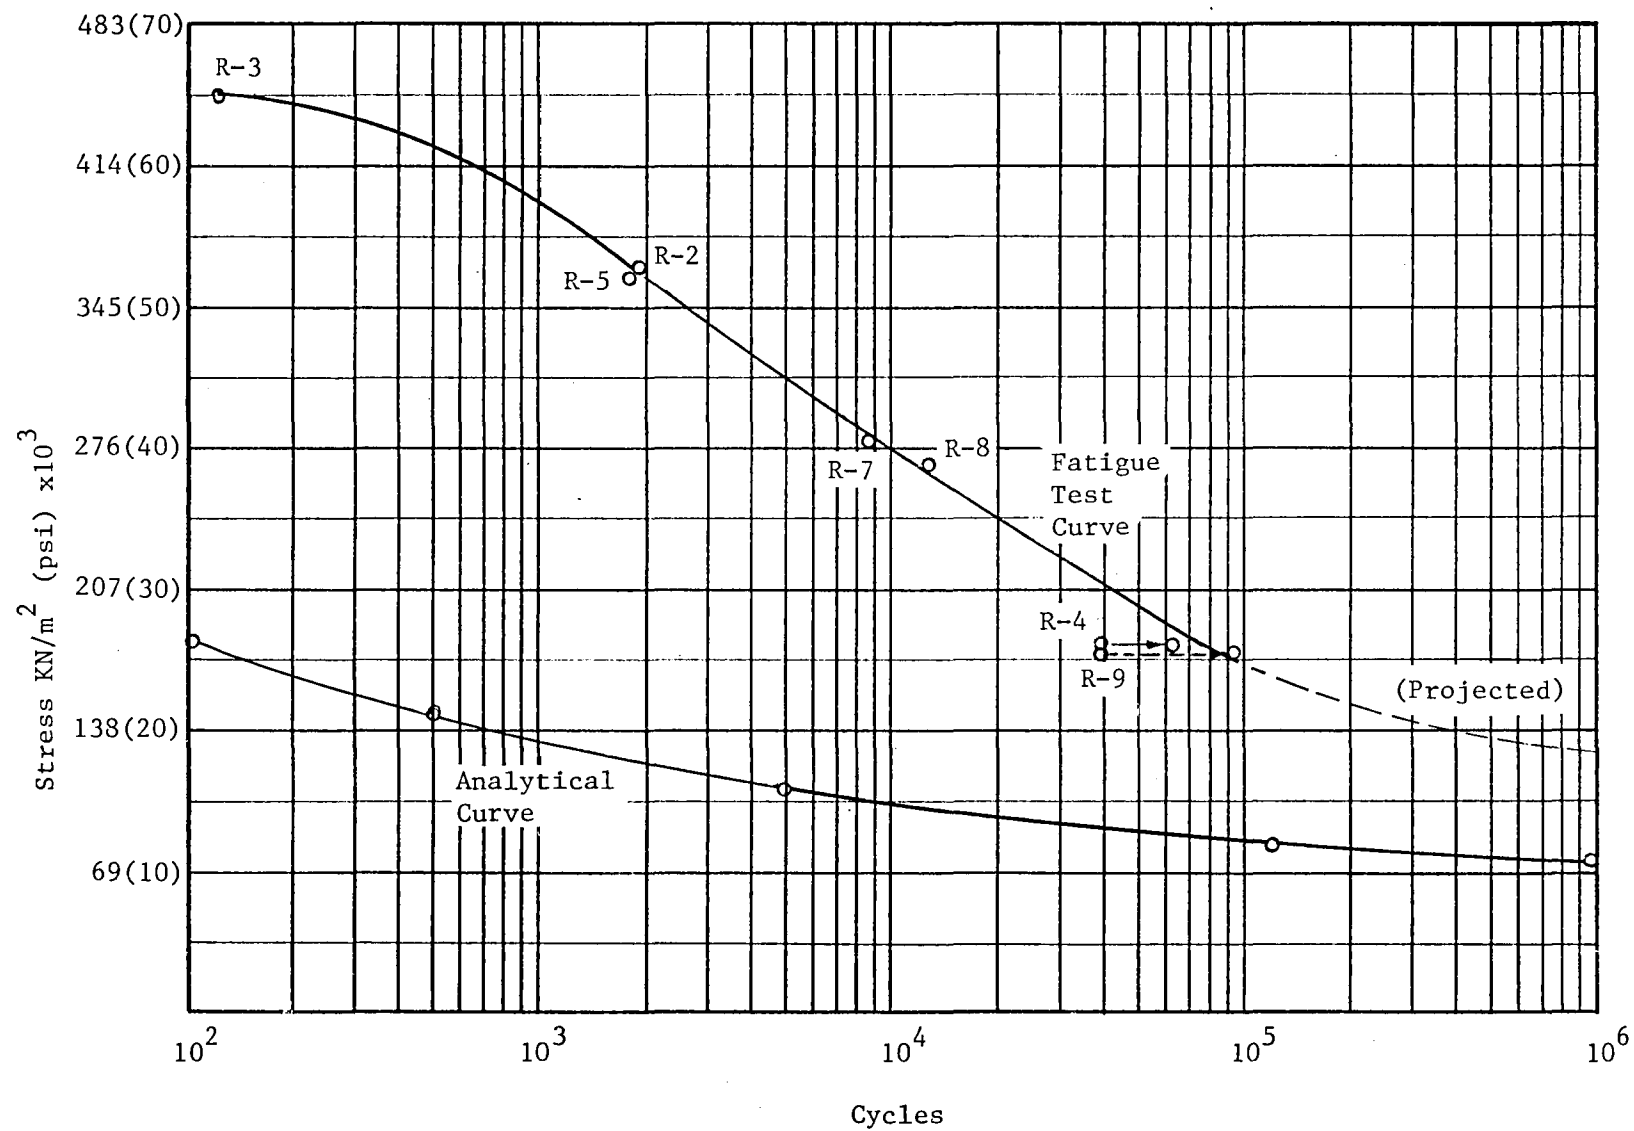
Figure II-12 CFME Trunnion Laminate S/N Curve
for Ambient Temperature

Failures listed in Table II-3 and the resulting S/N curve generated from the data (Figure II-12) consisted of catastrophic yielding of the entire laminate to the imposed loading condition. Deflections were analyzed to determine the points at which the deflection started to increase. Figure II-14 shows the ambient temperature S/N curve for the laminate, as well as a lower bound curve generated by selecting the points where deflection started to increase. This lower bound curve can be termed "first indication of laminate stiffness degradation". The area between the two curves is characterized by a rapid loss in specimen stiffness until catastrophic failure occurs at the upper limit. In all cases, a 10% increase in deflection almost corresponds to catastrophic failure of the specimen.

The two specimens tested at the 40% level, 21,360 N (4,800 lb), survived 40,000 cycles as specified in the test plan while all of the other specimens failed before the specified maximum cycle test limit was reached. In an attempt to achieve failure at the 40% level, one of the two specimens was cycled to failure, which occurred at 66,000 cycles. This failure occurred at the bolt holes and was attributed to the specimen design. Therefore, this was not considered a valid data point; failure of the gage section would have occurred at a higher cycle level. The second 40% specimen (R-9) which survived 40,000 cycles was re-installed into the test setup and cycled under 80% load 42,720 N (9,600 lb) in an attempt to calculate a damage factor which was assumed to be cumulative in a linear fashion. At the 80% level, this specimen failed at 1076 cycles. Failure was again attributed to the specimen design since failure did not occur in the gage section. However, using this data and the linear damage rule resulted in the following:

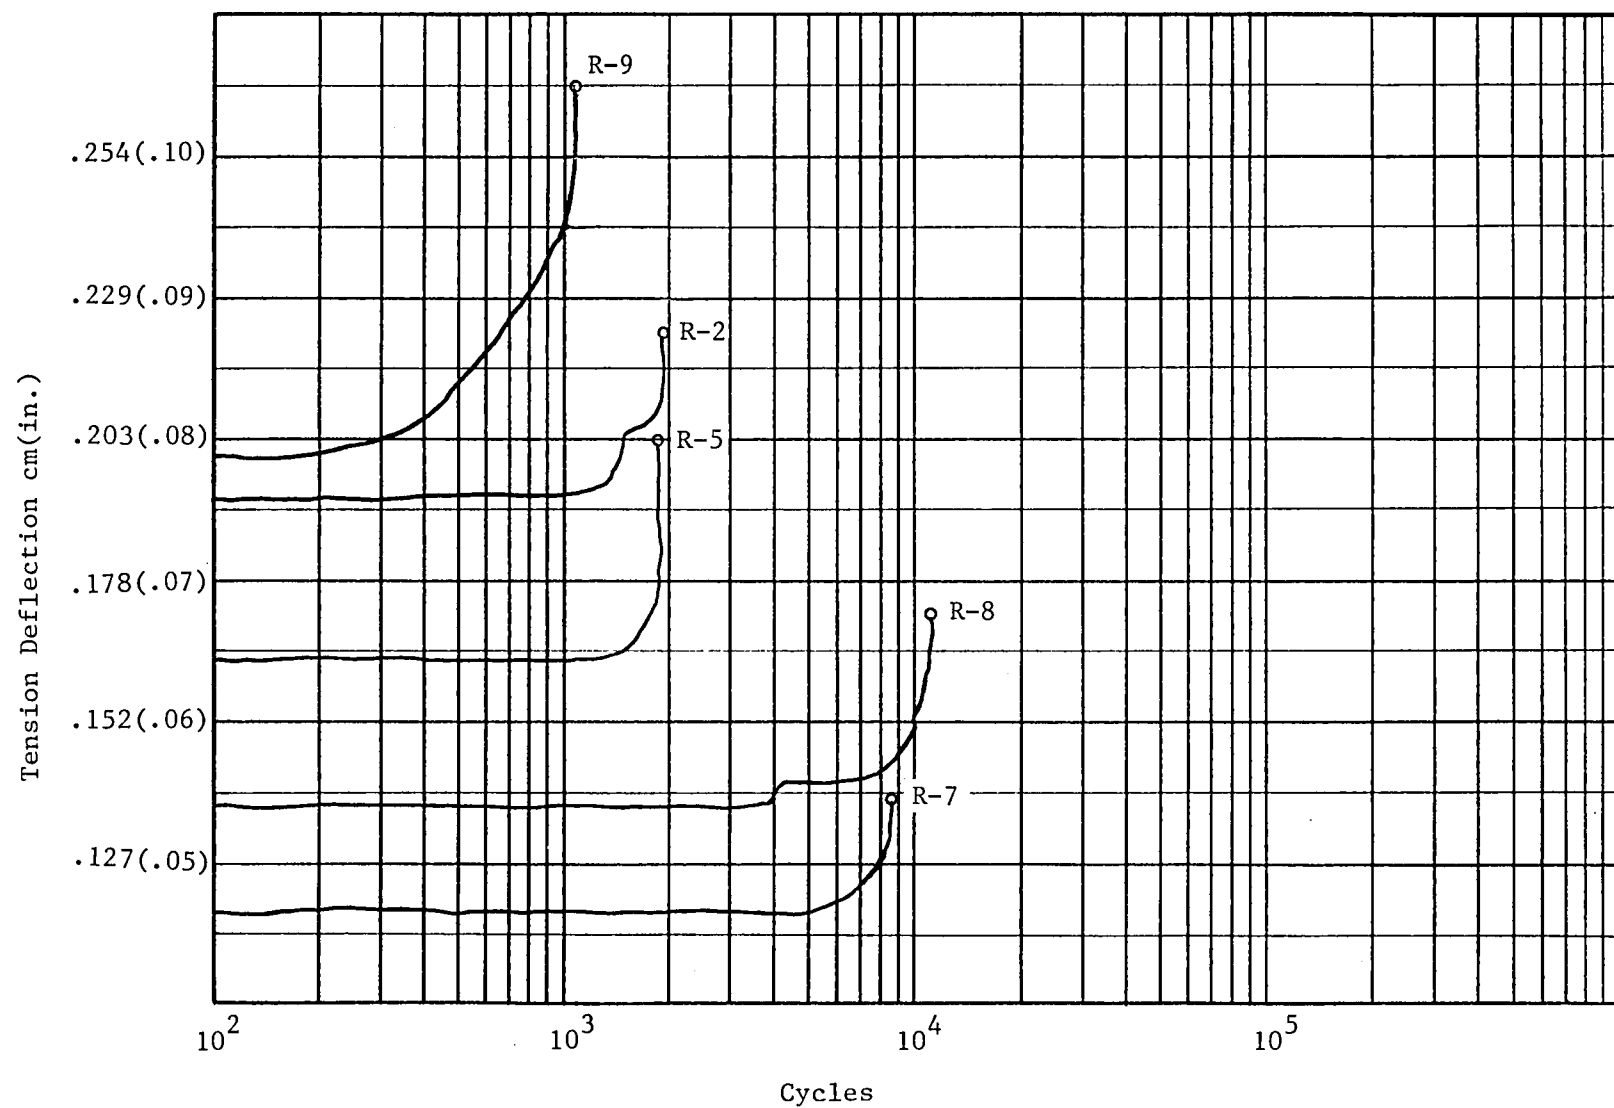
Figure II-13 Ambient Temperature Laminate Specimen
Test Deflection Data

Test fixture deflection was a near constant component, as was the specimen movement in the test fixture clevis. The main component, however was due to the specimen deflection which was a direct result of the load applied and the specimen configuration. The specimen configuration, or design, contributed to the overall deflection results obtained from the testing by inducing stress concentrations in the transition section and at the bolt hole locations. It is difficult to speculate whether stiffness degradation (deflection increase) was a result of failure in the laminate or due to specimen design. The end result, however, lies in the S/N curve generated from the catastrophic yielding of the laminate regardless of how the failure was induced. Deflection data indicate that the stiffness of the laminate was maintained throughout the major portion of the fatigue cycling, as shown in Figure II-14. A typical failed ambient test specimen is shown in Figure II-15.

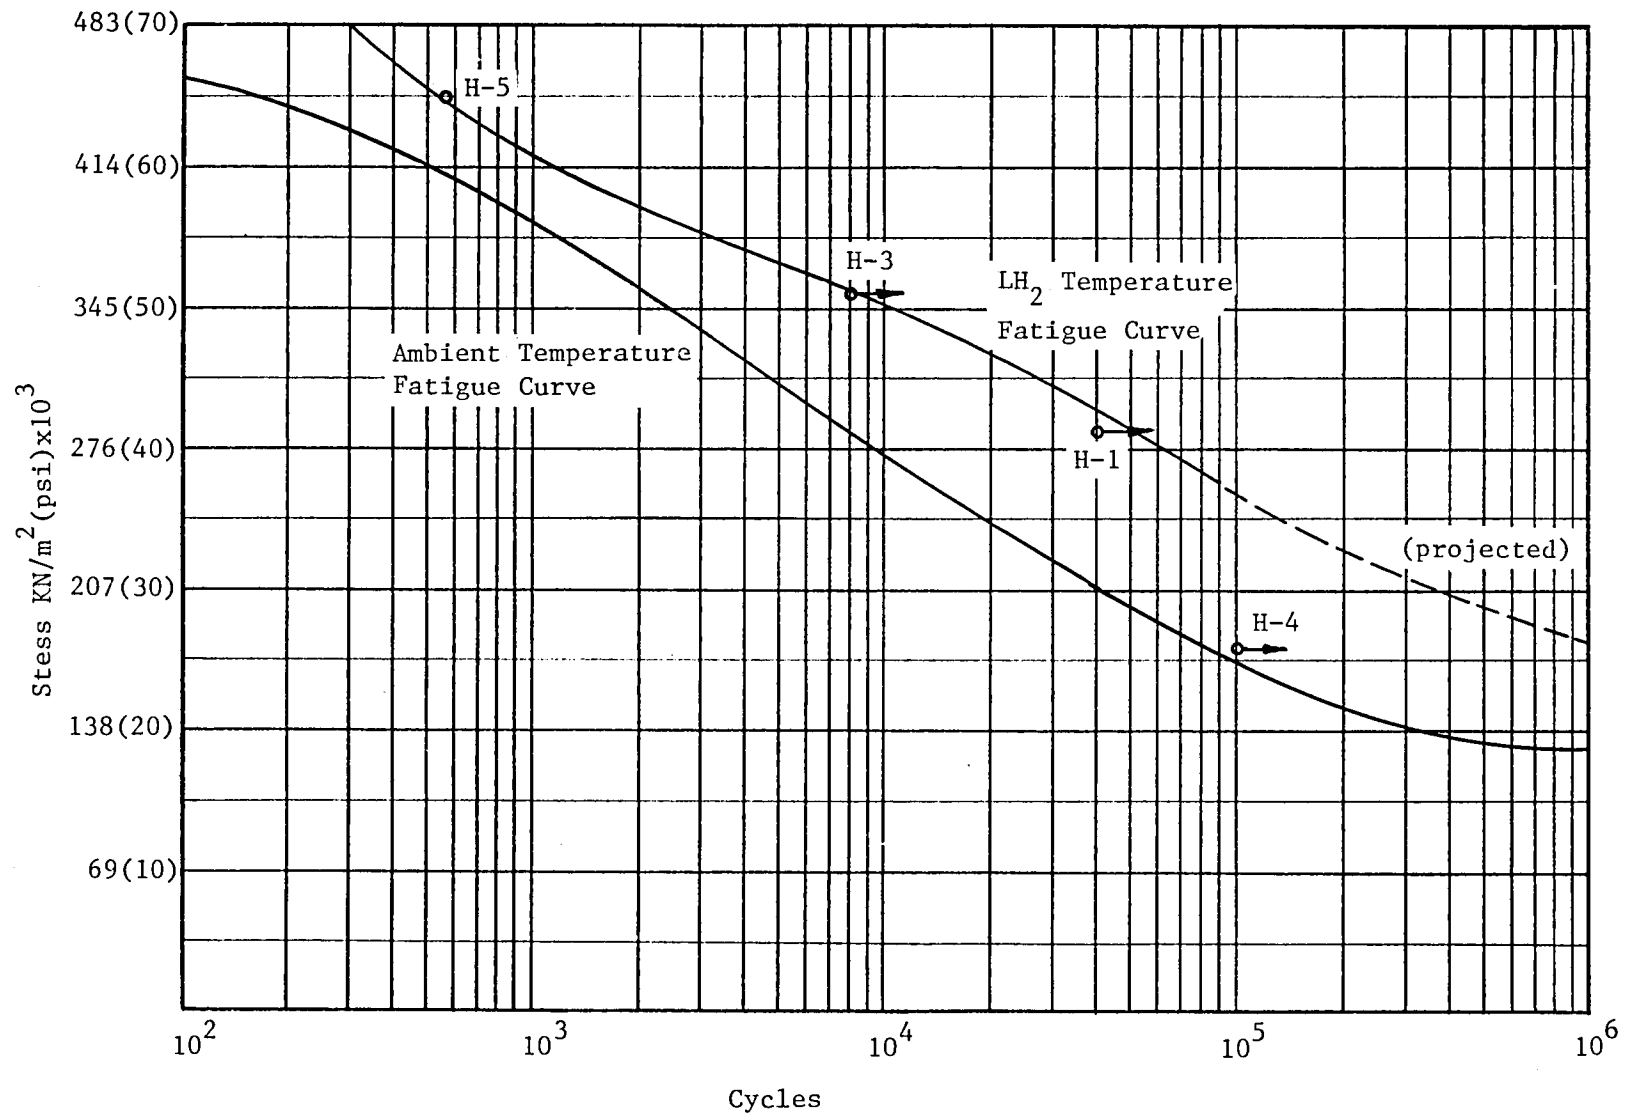
Figure II-16 CFME Trunnion Laminate LH₂
Temperature S/N Curve

Results of the LH₂ temperature fatigue tests are presented in Table II-4. Specimens were tested at the same 100%, 80%, 60%, and 40% levels of the baseline 12,000 lb load used for the ambient temperature tests.

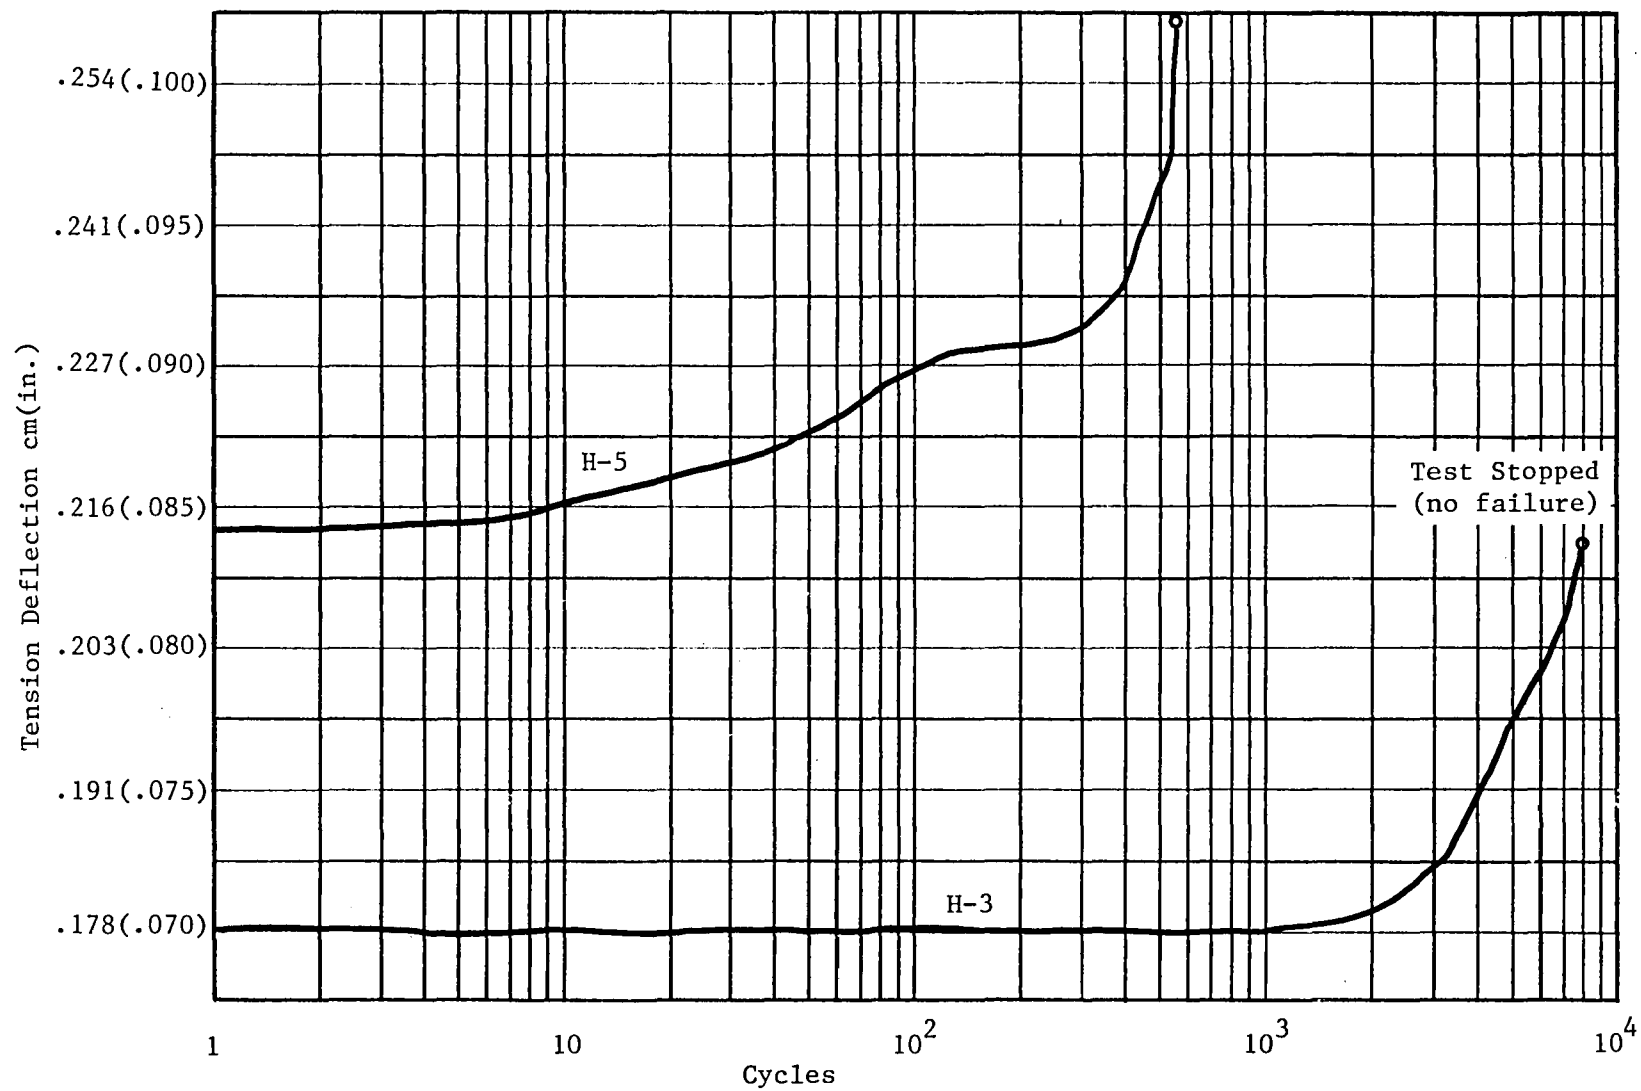
Figure II-17 CFME Trunnion Laminate Deflection at
LH₂ Temperature

Deflection data for the LH₂ tests are available only for specimen (H-5), which was loaded to 53,400 N (12,000 lb) and failed at 581 cycles, and for specimen (H-3), which was loaded to 42,720 N (9,600 lb) with no failure after 8,000 cycles. Again, the failure at 581 cycles occurred at the bolt holes rather than the gage section and was thus considered to be a conservative data point. Deflection data for the 40% and 60% specimens were not documented due to recorder limitations when frequency exceeded 2 Hz. Deflection data for specimen H-3 and H-5 are shown in Figure II-17. The only LH₂ test specimen to fail is shown in Figure II-18.

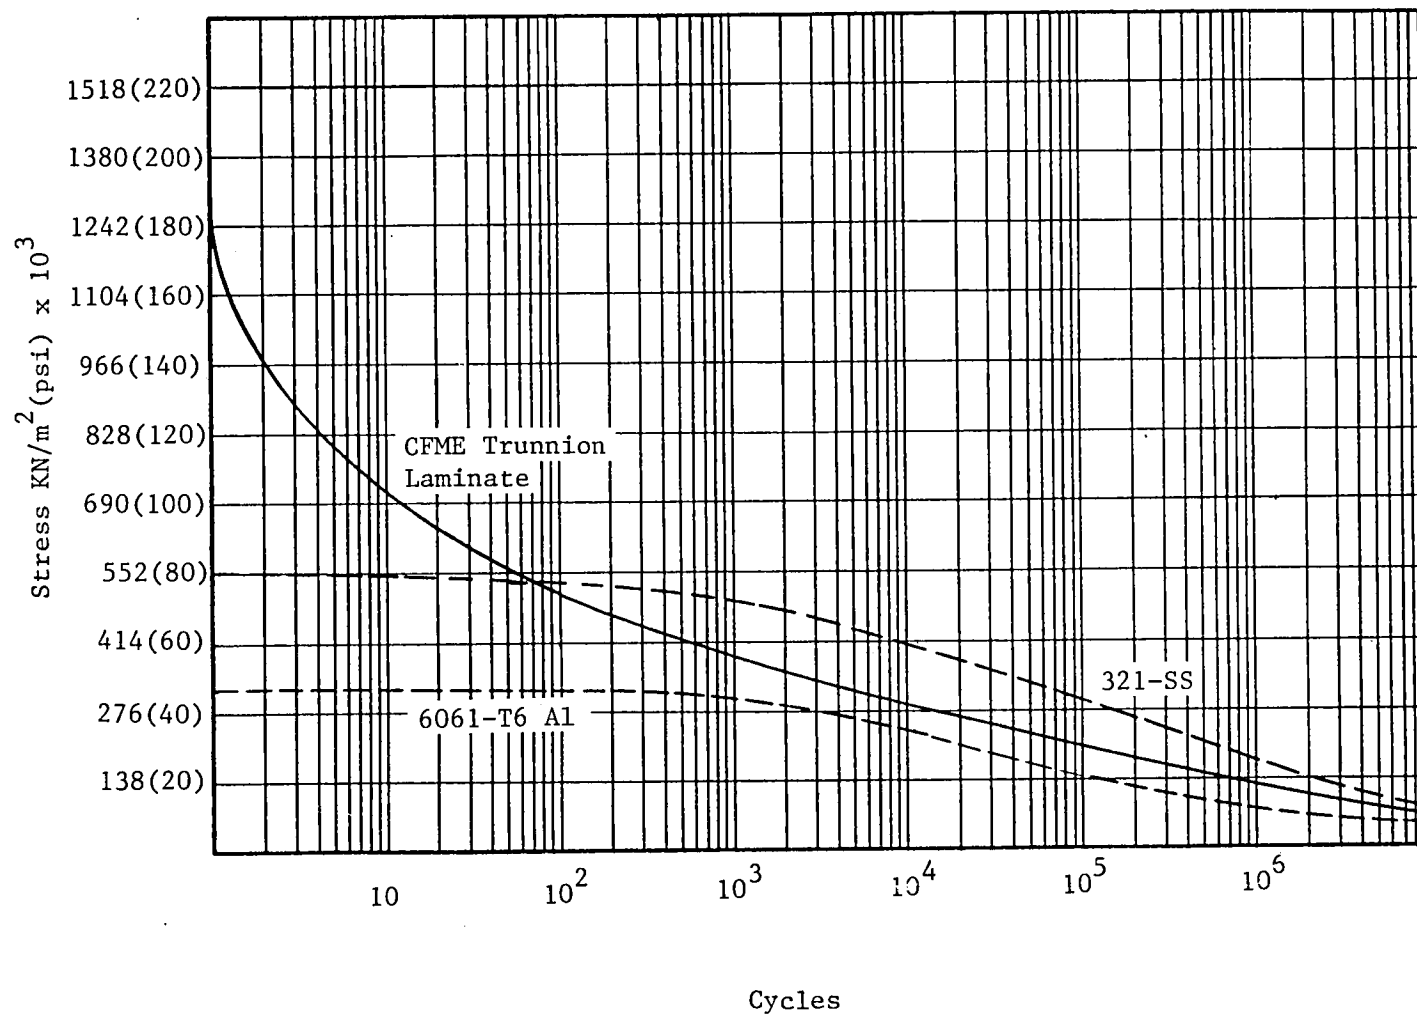
Figure III-1 CFME Trunnion Laminate S/N Curve
Comparison with 321 SS and 6061-T6 Al

One of the concerns resulting from the original CFME trunnion fatigue analysis was the high cumulative damage factor of 0.813 calculated for seven missions using a scatter factor of four on the number of fatigue cycles. This value was derived using laminate properties that were much lower than those obtained by Task I fatigue tests. Analysis of CFME trunnion cumulative damage factor based on Task I test data resulted in a damage of less than 0.1. This factor is much less than the 0.35 damage factor calculated for the pressure vessel and vacuum jacket. Based on these results, the trunnion is a low criticality item in the CFME liquid hydrogen supply tank. Results from Task I fatigue testing indicate that the trunnion laminate longitudinal S/N curve compares favorably with S/N curves for stainless steel and aluminum (see Figure III-1).
